CHAINS

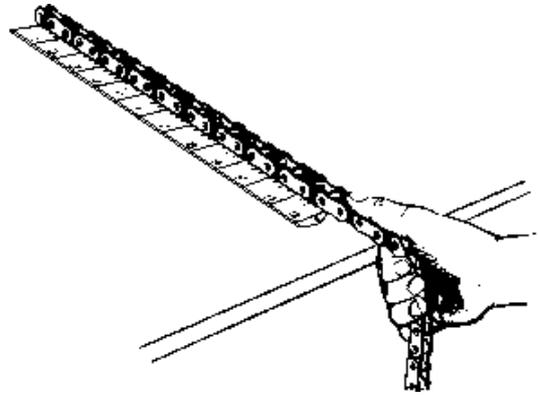
FIG. H2. *Measuring the chain.*

It is useful to know the extent of wear, and a simple test for this consists of measuring the chain with an ordinary foot-rule, steel for preference. Wear up to $\frac{1}{4}$ " per foot of chain length is accommodated by the depth of hardening of the bearing surfaces, and when this limit is reached the chain should be replaced.

With a new $\frac{1}{4}$ " pitch chain, 23 pitches will come to the $11\frac{1}{2}$ " mark on the rule, and a sufficiently accurate check for subsequent wear is to take a limit of $11\frac{3}{4}$ " for 23 pitches.

Naturally, the test should be made carefully to obtain an accurate result. The chain is first washed in kerosene to ensure that all joints are free, and laid unlubricated on a flat board. If it is anchored at one end by a nail the necessary tension to pull it out to its fullest extent can be applied with one hand, while measuring between the centres of the bearing pins.

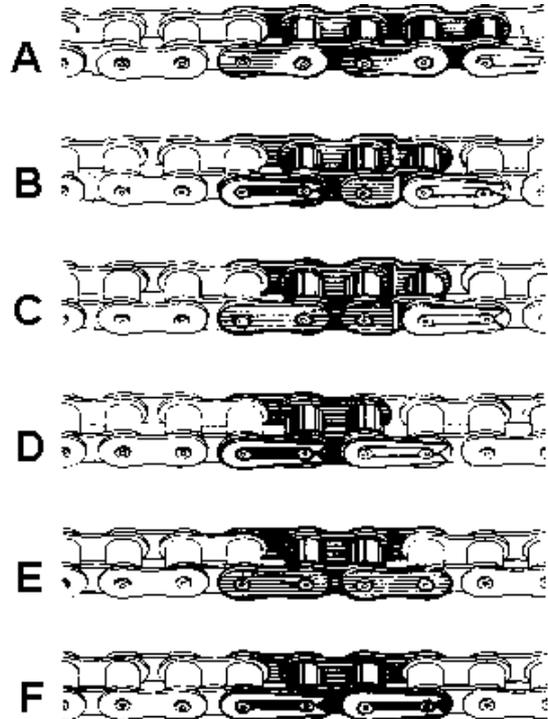
FIG. H3.

To **shorten** a chain containing an **even** number of pitches: remove the parts shown (A) Fig. H3, replace by cranked double link and single connecting link, parts shown (B) Fig. H3.

To **shorten** a chain containing an **odd** number of pitches: remove the parts shown (C) Fig. H3, replace by single connecting link and inner link, parts shown (D) Fig. H3.

To **repair** a chain with a broken roller or inner link, remove the parts shown (E) Fig. H3, replace by two single connecting links and one inner link, parts shown (F) Fig. H3.

The illustrations show temporary repairs on the roadside; for permanent repairs, the parts should be replaced by a riveted outer link.

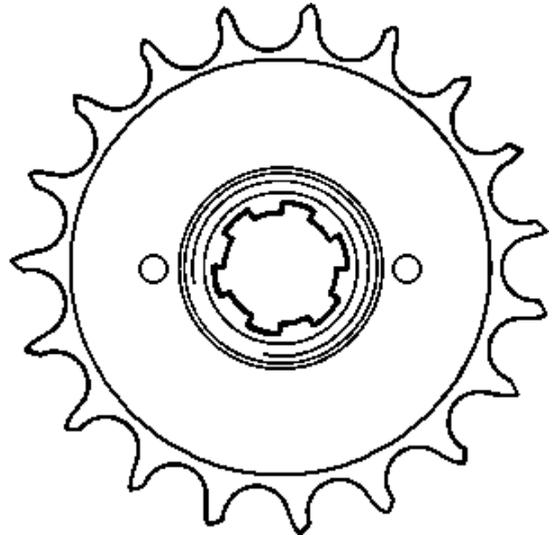
FIG. H4. *Worn sprocket.*

Sprockets which are excessively worn assume a "hooked" appearance, as shown above. When they are replaced check the new ones for accuracy. A new chain should fit completely round the teeth with a snug fit, neither too slack nor having a tight "springy" feel. The sprocket bore must be concentric, otherwise the chain will tend to slacken and tighten as the sprockets are rotated.

With the sprocket in position, a pointer fitted adjacent to the teeth edges will detect such faults, if any show up, the sprocket should be rejected, assuming that the wobble is not caused by a bent shaft. Failure to correct such faults will cause the chain to wear quickly and unevenly.
